# Building Pressure Testing

WHITEPAPER | NOVEMBER 2018

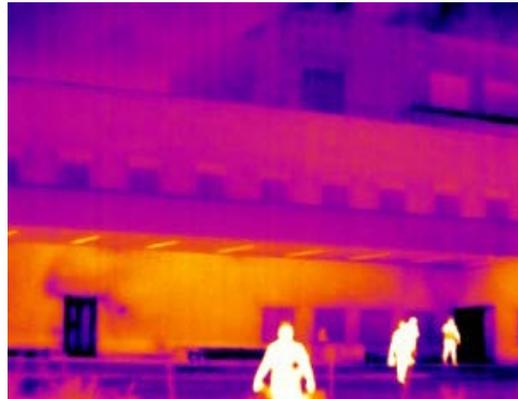
*Figure 1 – Major Hospital Infrared Thermographic Inspection Image*

Additionally, an infrared thermographic inspection using a fully radiometric infrared camera on the perimeter walls was conducted for the entire exterior of the building. This thermal inspection, which is normally performed during the building pressure test, was performed at a later date. Even without the simultaneous benefit of the pressure test, several openings were still identified. Some of the areas were confirmed due to localized temperature comfort issues reported after occupancy. The areas were all mitigated by sealing the cracks and voids further improving the tightness of the envelope.

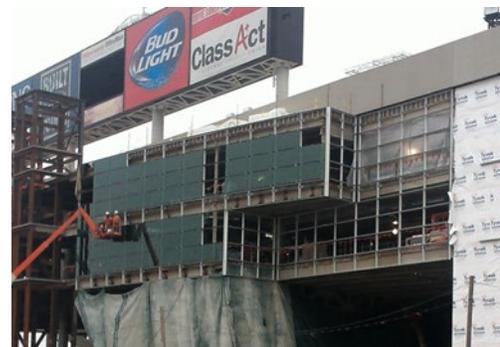
*Figure 2 – Thornton Academic Center for Excellence*

The UofL Thornton's Academic Center for Excellence is a two-story elevated building and features a total of 89,000 ft<sup>2</sup> of total test boundary surface area. The building is hanging from the existing structure of Cardinal Football Stadium. This construction is unique in that the envelope is exposed on all sides. The facade was primarily curtain wall with glazing and metal panels as seen in Figure 2.

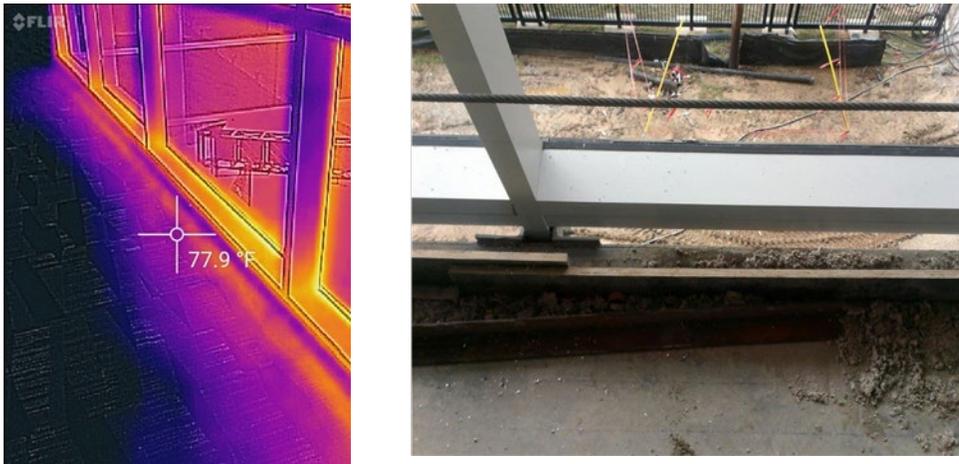
*Figure 3 – Images of curtain wall gap and thermal imagery of gap.*

After repairing the large opening, the building test was attempted again. The test results ultimately showed the building leakage to be 0.25 cfm/ft<sup>2</sup>. The primary cause of the building leakage was determined to be a large gap identified between the building slab and the curtain wall system. This occurred around the entire perimeter of curtain wall. This gap was discovered prior to construction during a review of the envelope design. The Architect's resolution was to fill this gap with expanding foam. During pressure testing, air could be felt infiltrating in this location. Figure 3 shows the picture of gap prior to applying expanding foam insulation. The team learned that while expanding foam is great at sealing a building envelope when used in a typical construction, it proved to be less effective than expected for filling large voids in the exterior envelope.

The building envelope likely could have performed better had the large gap been detailed differently during the design process. However, even with the intricacies of the architecture, the building still performed 35% better than IECC code minimum (0.40 cfm/ft<sup>2</sup>).
